REPORT TO: Mayor and Members of Council
DATE: March 6, 2019
FROM: Jill Bellchamber-Glazier, CAO-Clerk
SUBJECT: ESA Phase I & II Assessments – Municipal Lands

Reference: LON-00016318-EN

Re: Phase I & II Environmental Site Assessment
139 McRae Street and 208 Walker Street, Glencoe, Ontario

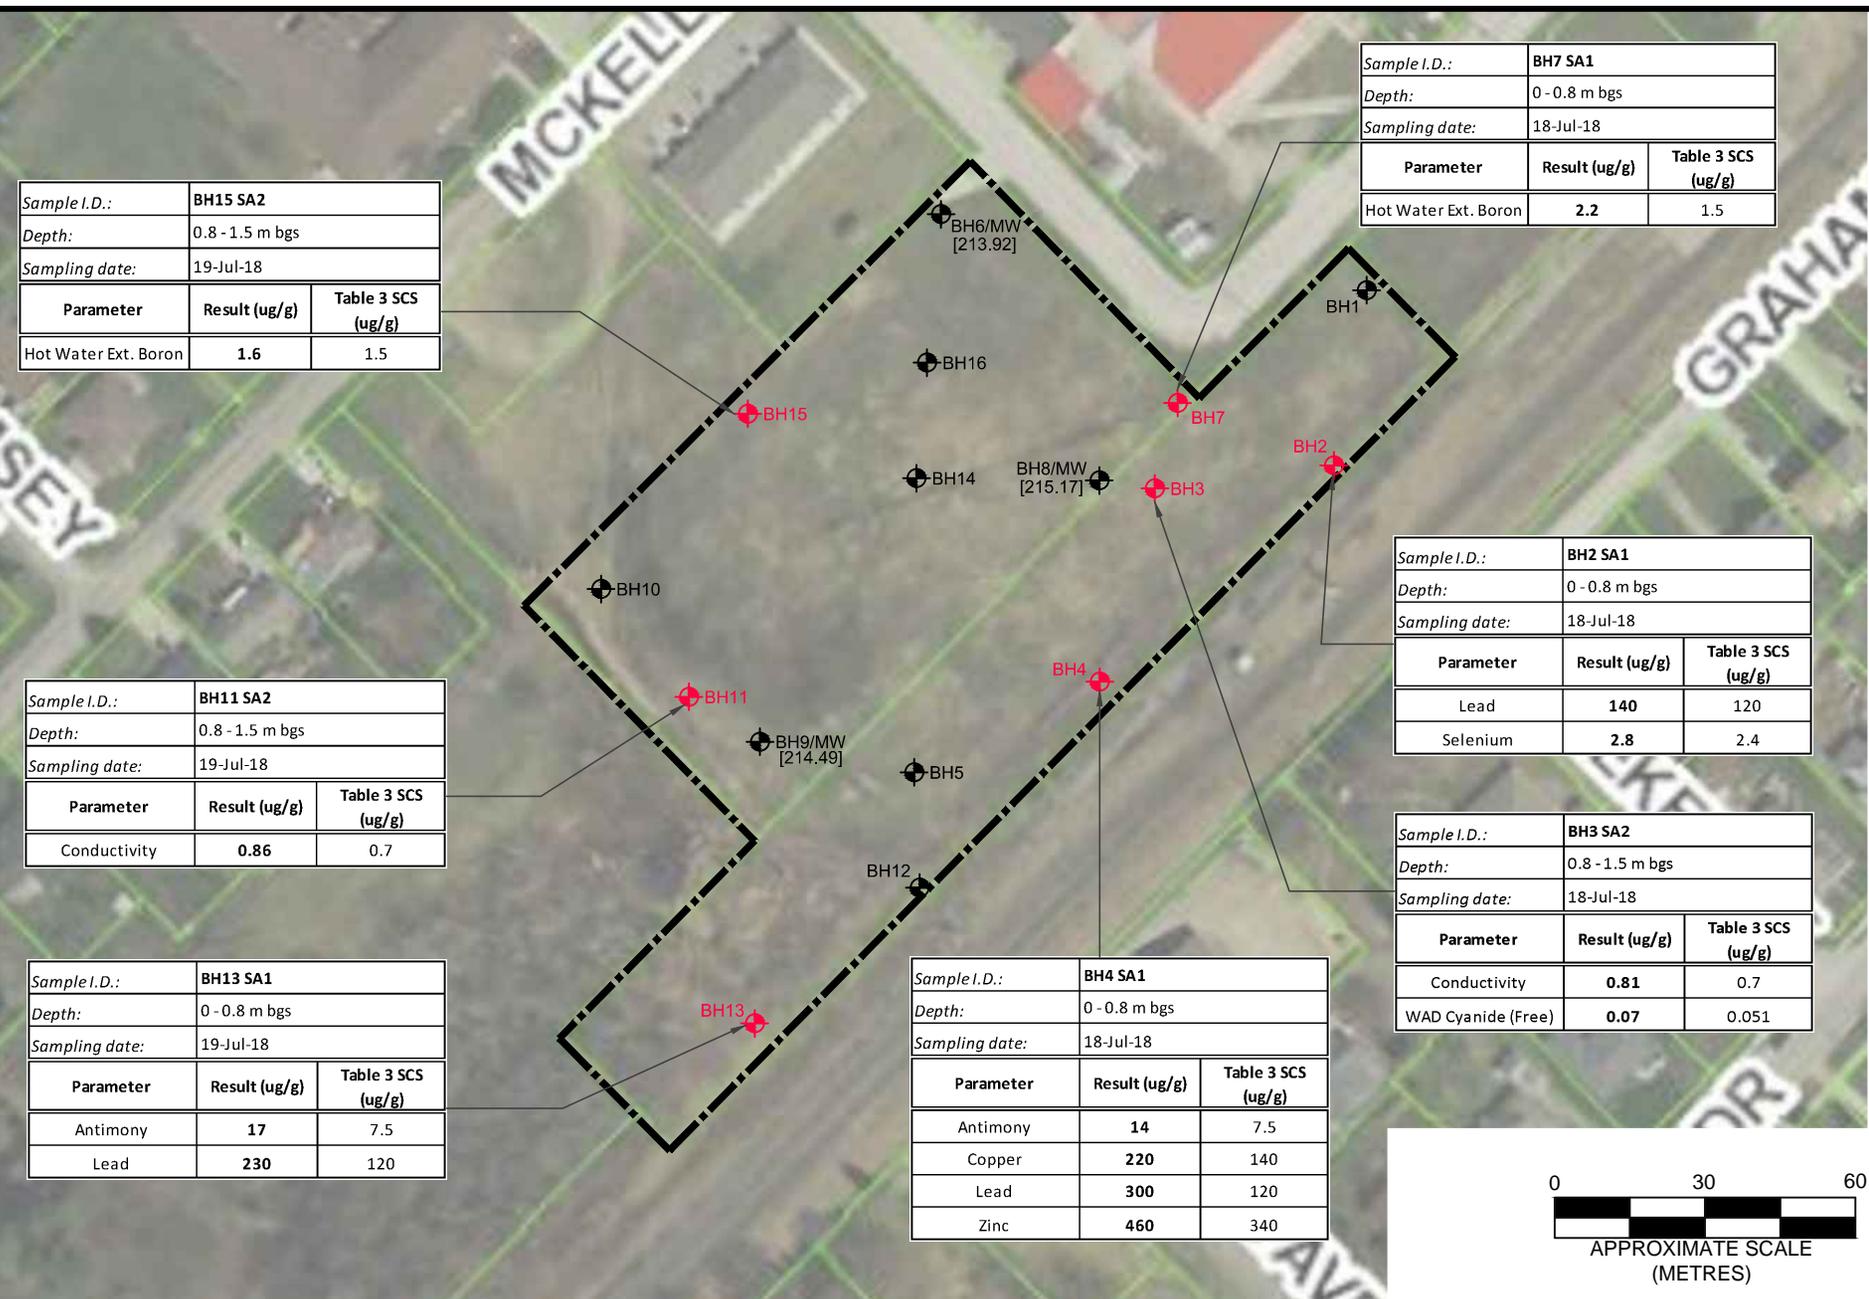
CLIENT:	MUNICIPALITY OF SOUTHWEST MIDDLESEX	
SITE:	208 WALKER STREET & 139 MCRAE STREET, GLENCOE, ONTARIO	
TITLE:	PLAN VIEW - METALS AND INORGANICS IN SOIL EXCEEDING THE 2011 MOECC TABLE 3 SCSs	
DATE:	PROJECT No:	FIG
AUGUST 2018	LON-00016318-EN	5

Selected soil samples were tested for various COCs including Metals and Inorganics, PAHs, VOCs, PHCs, Organochlorine Pesticides, Organophosphorus Pesticides, PCBs and Nitrates. Exceedances of a few metals and inorganic parameters, specifically Boron (HWS) and Conductivity were detected in some of the soil samples tested. All other parameters were detected at concentrations below their respective 2011

Selected soil samples were tested for various COCs including Metals and Inorganics, PAHs, VOCs, PHCs, Organochlorine Pesticides, Organophosphorus Pesticides, PCBs and Nitrates. Exceedances of various metals and PAH parameters, including lead, copper, antimony, zinc, selenium, benzo(a)pyrene, naphthalene etc., were detected in most of the soil samples tested. All other parameters were detected at concentrations below their respective 2011 MECP Table 3 SCSs in the soil samples tested.

Sample I.D.:	BH15 SA2	
Depth:	0.8 - 1.5 m bgs	
Sampling date:	19-Jul-18	
Parameter	Result (ug/g)	Table 3 SCS (ug/g)
Hot Water Ext. Boron	1.6	1.5

Sample I.D.:	BH7 SA1	
Depth:	0 - 0.8 m bgs	
Sampling date:	18-Jul-18	
Parameter	Result (ug/g)	Table 3 SCS (ug/g)
Hot Water Ext. Boron	2.2	1.5

Sample I.D.:	BH11 SA2	
Depth:	0.8 - 1.5 m bgs	
Sampling date:	19-Jul-18	
Parameter	Result (ug/g)	Table 3 SCS (ug/g)
Conductivity	0.86	0.7

Sample I.D.:	BH2 SA1	
Depth:	0 - 0.8 m bgs	
Sampling date:	18-Jul-18	
Parameter	Result (ug/g)	Table 3 SCS (ug/g)
Lead	140	120
Selenium	2.8	2.4

Sample I.D.:	BH13 SA1	
Depth:	0 - 0.8 m bgs	
Sampling date:	19-Jul-18	
Parameter	Result (ug/g)	Table 3 SCS (ug/g)
Antimony	17	7.5
Lead	230	120

Sample I.D.:	BH3 SA2	
Depth:	0.8 - 1.5 m bgs	
Sampling date:	18-Jul-18	
Parameter	Result (ug/g)	Table 3 SCS (ug/g)
Conductivity	0.81	0.7
WAD Cyanide (Free)	0.07	0.051

Sample I.D.:	BH4 SA1	
Depth:	0 - 0.8 m bgs	
Sampling date:	18-Jul-18	
Parameter	Result (ug/g)	Table 3 SCS (ug/g)
Antimony	14	7.5
Copper	220	140
Lead	300	120
Zinc	460	340

It is recommended to complete additional boreholes and analytical testing on this parcel to delineate the vertical and lateral extent of impact. This information will be used to establish a cost estimate for remediation of this parcel in order to support the filing of an RSC to allow the proposed use. Additional boreholes will also be completed along the boundary with the south parcel where PAH and metals impacts had been identified.

Regardless of the option chosen, it will be required to complete additional boreholes and analytical testing on this parcel to delineate the vertical and lateral extent of impact. This information will be used to establish a cost estimate for possible remediation of this parcel in order to support the filing of an RSC or to provide information for the SSRA/SLRA.

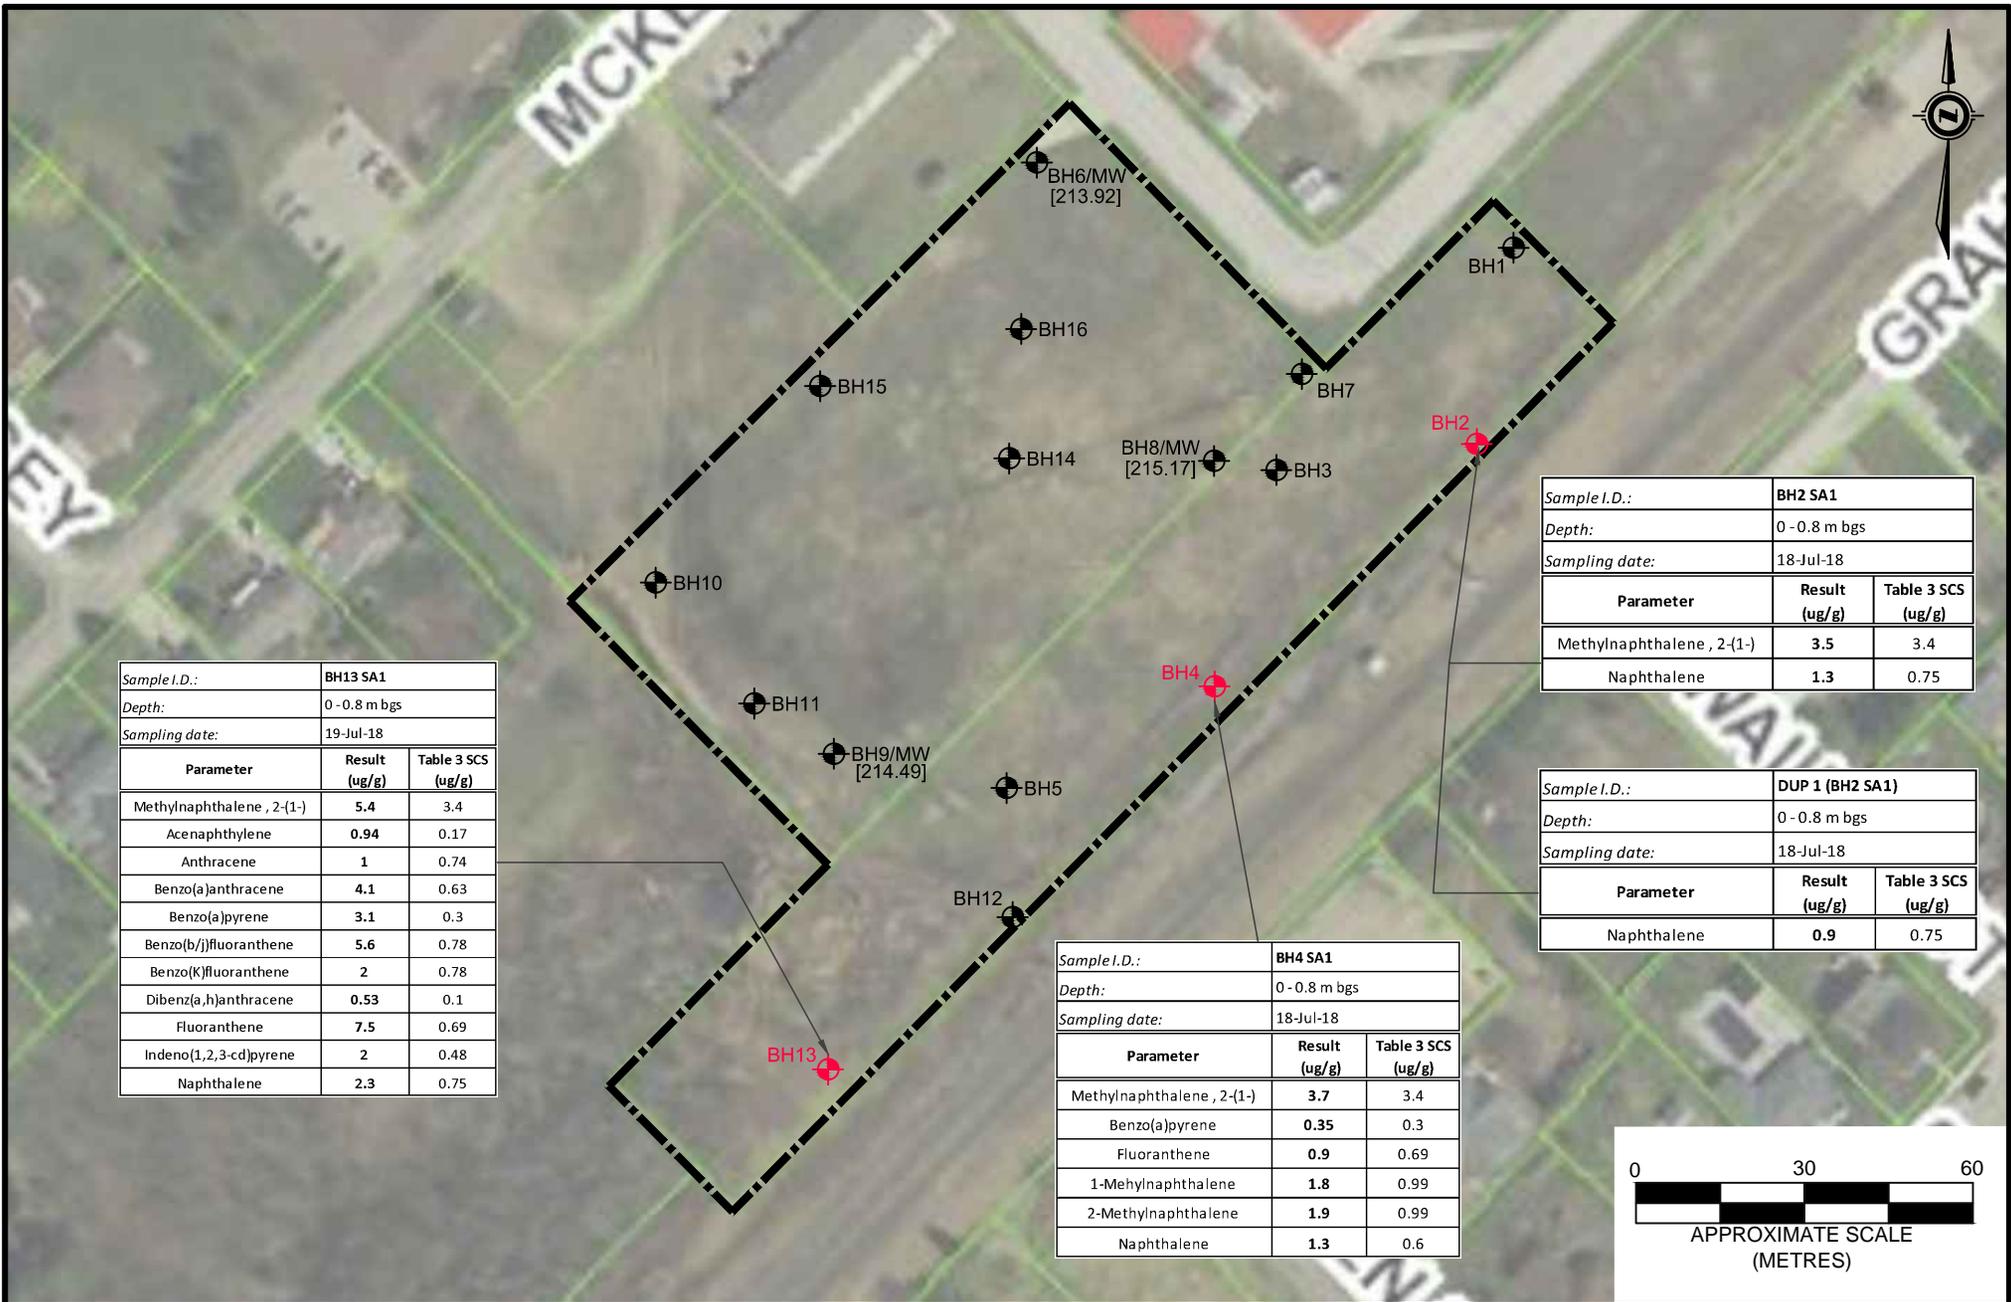
CLIENT: MUNICIPALITY OF SOUTHWEST MIDDLESEX
 SITE: 208 WALKER STREET & 139 MCRAE STREET, GLENCOE, ONTARIO
 TITLE: PLAN VIEW - METALS AND INORGANICS IN SOIL EXCEEDING THE 2011 MOECC TABLE 3 SCSs
 DATE: AUGUST 2018 PROJECT No: LON-00016318-EN FIG 5

The findings of the Phase II ESA indicated limited impact from Boron (HWS) and Conductivity in the upper fill material on the north parcel. These parameters are considered more of a phytotoxicological parameter which is a concern for plant growth. The vertical and lateral extent of the Boron (HWS) and Conductivity impacts have not been delineated.

The findings of the Phase II ESA indicated impact from various metals and PAH parameters, including lead, copper, antimony, zinc, selenium, benzo(a)pyrene, naphthalene etc., in most of the soil samples tested from the south parcel. The vertical and lateral extent of the impacts have not been delineated however it is expected that most of the parcel is impacted. The impact appears to be located within the cinder fill which is present beneath a thin layer of topsoil or granular fill and extends to an average depth of about 1.5m.
